Fuel Injection Control Module (FICM) Programming

Verifying 58 Volt Operation

Procedure A - Verify 58 Volt Operation (Optional)

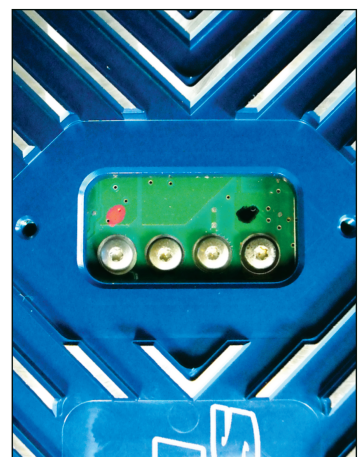
1. With the engine off, remove the two screws securing the access cover on the back side of the FICM (opposite side of the connectors). **DO NOT REMOVE THE SCREWS ON THE FRONT OF THE FICM AS THIS WILL VOID THE WARRANTY.**

3. Using a digital multi-meter in DC voltage measurement mode, place the black lead on the screw with the black dot and the red lead on the screw with the red dot. Voltage should be 58 volts (+/- 4). **USE CAUTION NOT TO TOUCH RED METER LEAD TO FICM CASE, DOING SO WILL PERMANENTLY DAMAGE FICM.**

Although optional, you may want to verify 58 volt operation by taking a direct measurement at the back of the FICM using a multi-meter.
